FACE INVESTIGATION

SUBJECT: Laborer Dies From Fall Through Skylight While Shoveling Snow on Roof

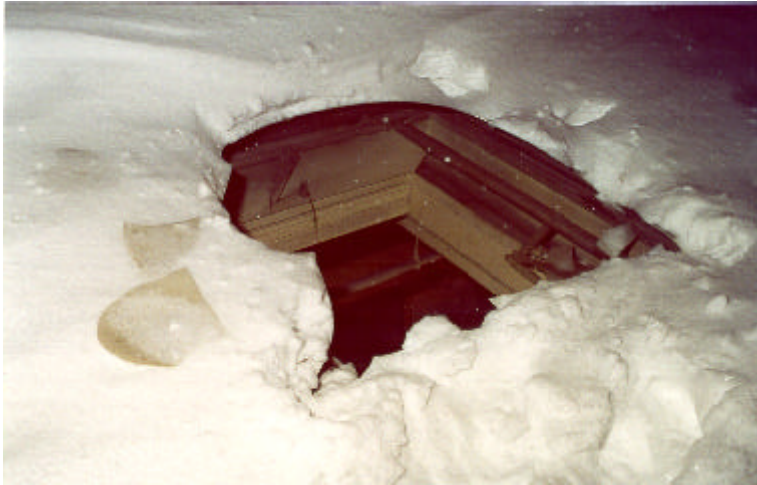
Discussion: According to 29 CFR 1910.23 (a)(4) "Every skylight floor opening and hole shall be guarded by a standard skylight screen or a fixed standard railing on all exposed sides." Additional requirements are specific about the design and capacity of the guard. In this case, the plastic bubble shell over the skylight opening did not meet the guarding standard, and the victim fell through the opening when he accidentally stepped on the shell.

Figure 1. This picture shows the broken skylight where victim fell.

Recommendation #1: Employers should guard skylight openings.

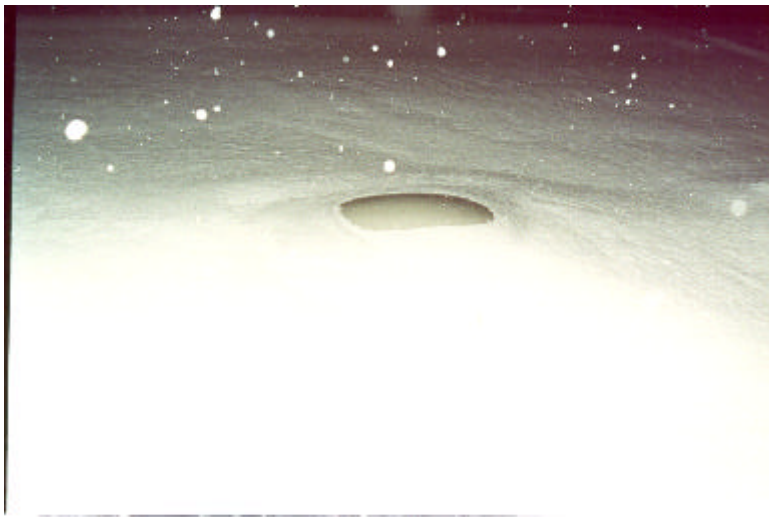
Figure 2. This picture shows an adjacent skylight, which was unguarded and snow covered.

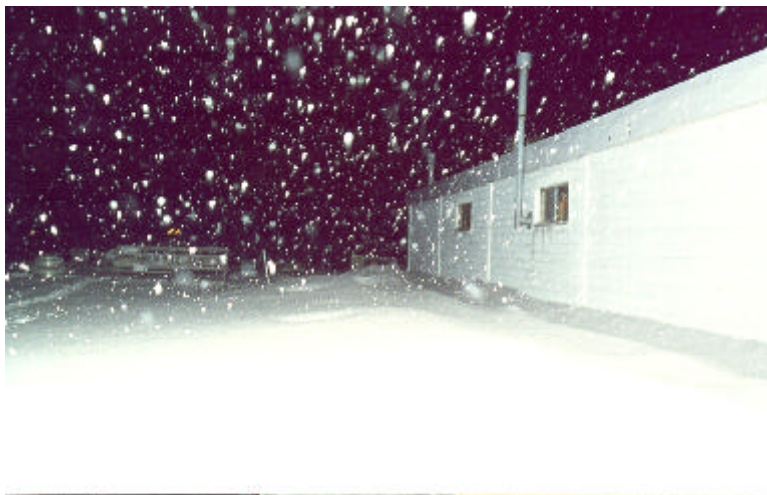
Discussion: The rooftop where the incident occurred was frequently used by employees for breaks. It had also been designated by the company as an exit area for emergency evacuation. The roof was not designed for these purposes, but the company did not prohibit access to the rooftop. Entrance to hazardous areas through doorways should be controlled with doorlocks, and should be marked with warning signs. While not directly a cause of this fatality, the unsafe practice of using the rooftop for breaks placed the victim and co-workers at risk of falling through skylights and from the roof edge.

Figure 3. This picture shows the rooftop view with snow drifts over the skylights.

Recommendation #2: Employers should lock all doors that provide access to unguarded rooftops.
